**Flood Control Project Maintenance
Levee Inspections**

Maintenance Issue Types Only, Levee Inspection Report By Mile - Spring 2017

Tehama County Flood Control and Water Conservation District

Waterway	Bank	Unit Miles	Inspection Start/End	Inspector
Unit No. 01 Deer Creek	Left	4.22	04/25/2017 04/25/2017	Bob Duffey

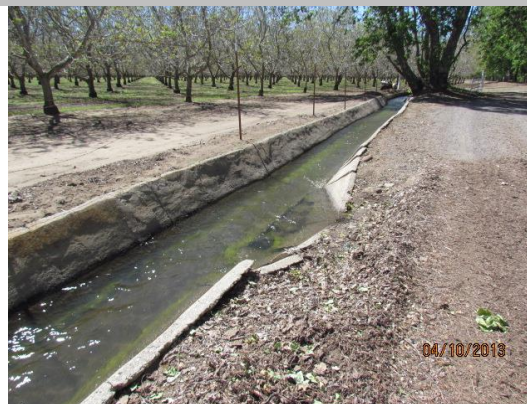
Photo 1 of 1 : SP_2017_NA0019_78_19_20170315_00006.jpg

LM Start	0.46	Rating **	M	Issue No.	19
LM End	0.46	Issue Type +	Ma	Location *	LS
Category	Earthen Levee			GPS Latitude/Longitude	
				Start	End
Item	Erosion / Bank Caving			39.972339 °	39.972339 °
				-121.988763 °	-121.988763 °
DWR ID	DWR_NA0019_01_s_2013_19				
Comment Code					
E1 : Note and monitor erosion site.					
Inspector Comment

View of the erosion along the landside slope.

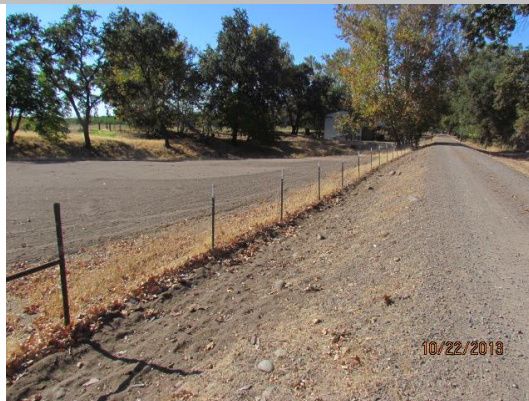
Photo 1 of 1 : SP_2017_NA0019_78_21_20170315_00008.jpg

LM Start	1.52	Rating **	M	Issue No.	21
LM End	1.52	Issue Type +	Ma	Location *	LS
Category	Earthen Levee			GPS Latitude/Longitude	
				Start	End
Item	Animal Control			39.969419 °	39.969419 °
				-122.007850 °	-122.007850 °
DWR ID	DWR_NA0019_01_f_2013_21				
Comment Code					
A2 : Repair the levee slope damaged by livestock and prevent large animal access.					
Inspector Comment

View of the erosion caused by livestock on both slope of the levee.

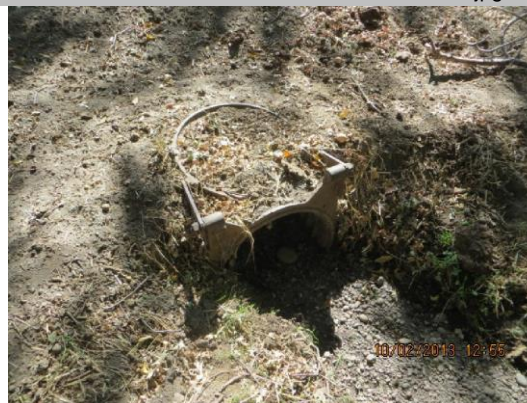
Photo 1 of 3 : UCIP_SP_2017_51437_36922.jpg

FS_ID:51437
DS_ID:20770
EP_NO: N/A
Repair Type: Non-Urgent
Crossing Status: Found
UCIP Comments: 12/05/2016 Sediment buildup inside pipe (see photo) and sediment buildup on WS blocking flap gate. Crossing has been downgraded from Urgent to Non-Urgent crossing was closed on both WS and LS. (O. Magana - DWR UCIP)10/02/2013 Flapgate blocked by soil buildup. (W. Wylie - DWR UCIP)
FIELD_STRUCT_DESC: 24-inch steel drainage pipe through the levee, 1.5 feet below the crown. Flap gate on the waterside (WS) toe.
[Additional Reference(s): DWR Levee Log, 1992. USACE Sacramento O&M Manual Unit 509, March 1957, As-built drawings available 50-4-2394 (Station 185+40)].
FS Date: 12/5/2016

Flapgate on WS toe.

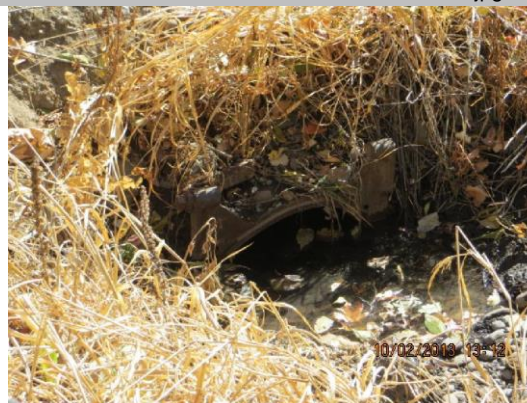
Photo 1 of 3 : UCIP_SP_2017_51438_36925.jpg

FS_ID:51438
DS_ID:20769
EP_NO: N/A
Repair Type: Urgent
Crossing Status: Found
UCIP Comments: 12/05/2016 same as last inspection. Crossing remains "Urgent" WS opened during flood season due to damaged flap gate. (O. Magana - DWR UCIP)10/02/2013 Flapgate missing or buried on WS toe. Pipe partially blocked by soil on WS toe. (W. Wylie - DWR UCIP)
FIELD_STRUCT_DESC: 24-inch corrugated metal drainage pipe through the levee, 7 feet below the crown. Flap gate located on the waterside (WS) end. A 5-foot by 5-foot concrete control structure located on the landside (LS) toe. [Additional Reference(s): DWR Levee Log, 1992. USACE Sacramento O&M Manual Unit 509, March 1957, As-built drawing no. 50-4-2394 (Station 176+10)].
FS Date: 12/5/2016

Pipe on WS toe with flapgate hinges.

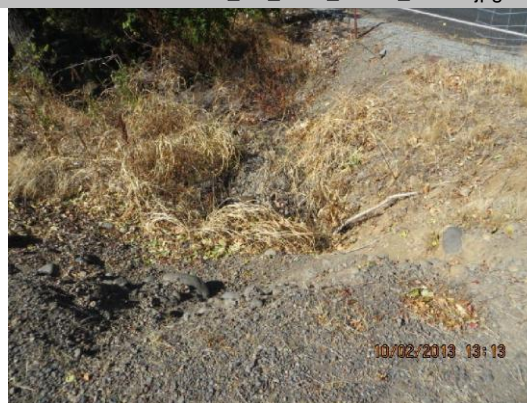
Photo 2 of 3 : UCIP_SP_2017_51438_36924.jpg

Outlet on WS toe.

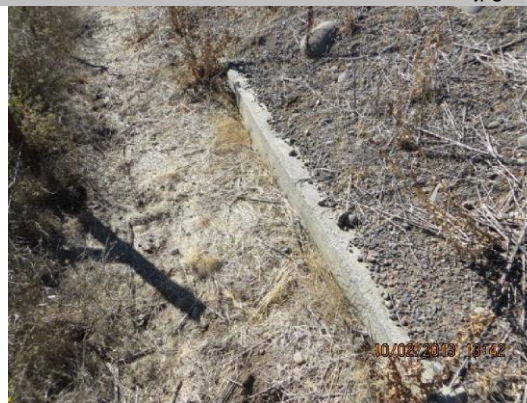
Photo 1 of 1 : UCIP_SP_2017_22823_38941.jpg

LM Start	2.57	Rating **	M	Issue No.	283
LM End	2.57	Issue Type +	Ma	Location *	WS
Category	Supplemental			GPS Latitude/Longitude	
				Start	End
Item	DWR UCIP LMA Responsibility			39.966363 °	39.966363 °
				-122.025755 °	-122.025755 °
DWR ID					
Comment Code					
Inspector Comment					
FS_ID:22823					
DS_ID:20877					
EP_NO: N/A					
Repair Type: Non-Urgent					
Crossing Status: Found					
UCIP Comments: Headwall covered with soil. Needs to be cleared at both ends.					
FIELD_STRUCT_DESC: 24-inch Corrugated mtl pipe through the levee 5-feet below the crown. Calco automatic drainage gate.					
Originally included in O+M manual (1957). As-built drawings available 50-4-2394.					
FS Date: 10/2/2013

Concrete headwall on LS toe.

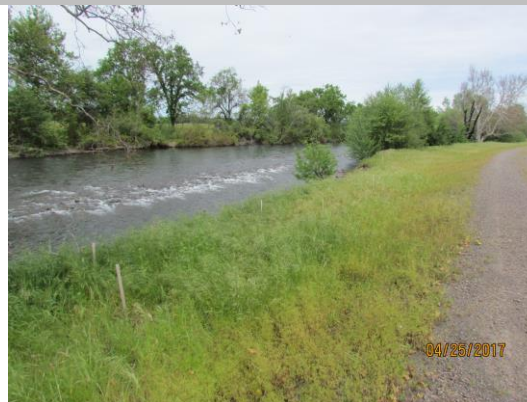
Photo 1 of 1 : SP_2017_NA0019_78_43_20170505_00064.jpg

LM Start	2.76	Rating **	U	Issue No.	43
LM End	2.78	Issue Type +	Ma	Location *	WS
Category	Earthen Levee			GPS Latitude/Longitude	
				Start	End
Item	Erosion / Bank Caving			39.964990 °	39.964763 °
				-122.028740 °	-122.029082 °
DWR ID	DWR_NA0019_01_s_2017_43				
Comment Code					
E2 : Schedule repair of erosion site prior to the next inspection.					
Inspector Comment					
Repair the erosion along the water side slope.

View of erosion along waterside toe.

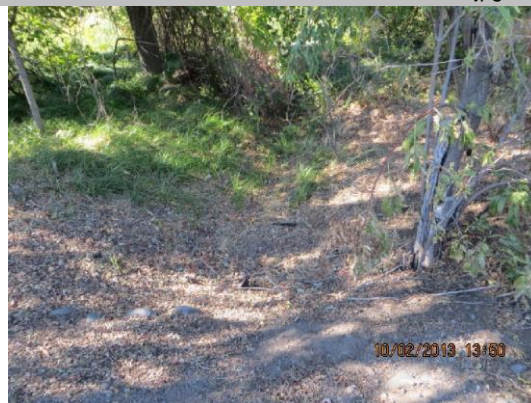
Photo 1 of 2 : UCIP_SP_2017_22824_38946.jpg

FS_ID:22824
DS_ID:20767
EP_NO: N/A
Repair Type: Non-Urgent
Crossing Status: Found
UCIP Comments: Pipe blocked by soil.
FIELD_STRUCT_DESC: 24-inch pipe through the levee 6-feet below the crown. Flap gate on the waterward end. Originally included in O+M manual (1957). As-built drawings available 50-4-2394.
FS Date: 10/2/2013

Flapgate blocked by soil and debris.

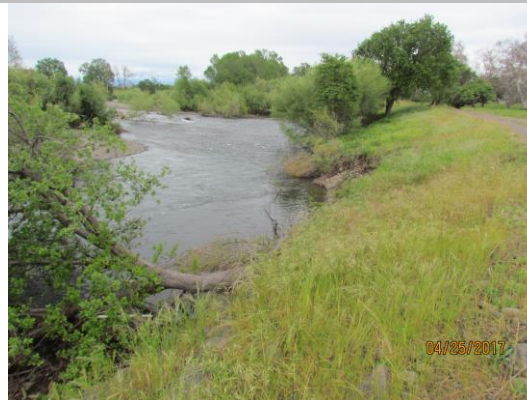
Photo 1 of 1 : SP_2017_NA0019_78_44_20170505_00065.jpg

LM Start	3.43	Rating **	U	Issue No.	44
LM End	3.43	Issue Type +	Ma	Location *	WS
Category	Earthen Levee			GPS Latitude/Longitude	
				Start	End
Item	Erosion / Bank Caving			39.946838 °	39.946838 °
				-122.051470 °	-122.051470 °
DWR ID	DWR_NA0019_01_s_2017_44				
Comment Code					
Inspector Comment					
Repair the erosion along the water side slope.

View of erosion along the waterside slope.

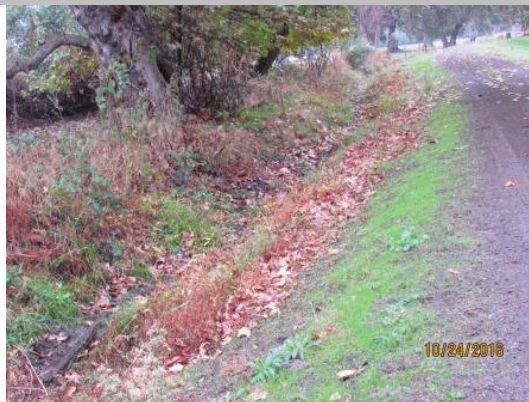
Photo 1 of 1 : SP_2017_NA0019_78_35_20170315_00010.jpg

LM Start	3.58	Rating **	M	Issue No.	35
LM End	3.58	Issue Type +	Ma	Location *	LS
Category	Earthen Levee			GPS Latitude/Longitude	
				Start	End
Item	Vegetation			39.946051 °	39.946051 °
				-122.053985 °	-122.053985 °
DWR ID	DWR_NA0019_01_f_2016_35				
Comment Code					
V2 : Remove the wild growth other than native grasses from the levee slopes.					
Inspector Comment

View of the vegetation along the landside slope and toe.

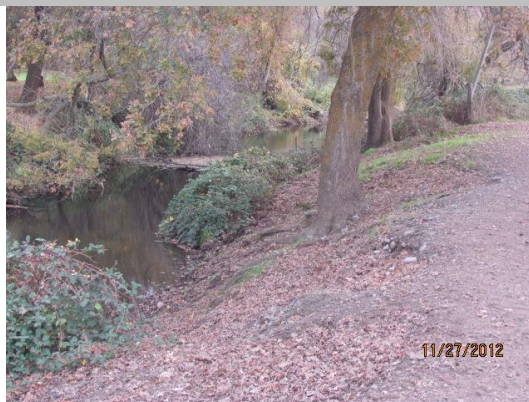
Photo 1 of 1 : SP_2017_NA0019_78_15_20170315_00002.jpg

LM Start	3.68	Rating **	M	Issue No.	15
LM End	3.68	Issue Type +	Ma	Location *	LS
Category	Earthen Levee			GPS Latitude/Longitude	
				Start	End
Item	Slope Stability			39.945045 °	39.945045 °
				-122.053469 °	-122.053469 °
DWR ID	DWR_NA0019_01_f_2012_15				
Comment Code					
S1 : Repair slope instability.					
Inspector Comment

View of the erosion caused by livestock along the landside slope.

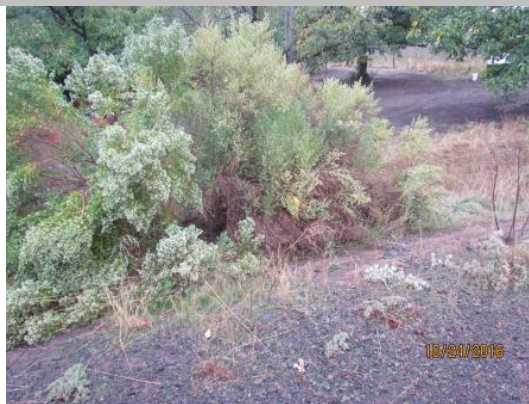
Photo 1 of 1 : SP_2017_NA0019_78_16_20170315_00003.jpg

LM Start	3.75	Rating **	M	Issue No.	16
LM End	3.75	Issue Type +	Ma	Location *	LS
Category	Earthen Levee			GPS Latitude/Longitude	
				Start	End
Item	Vegetation			39.944407 °	39.944407 °
				-122.054104 °	-122.054104 °
DWR ID	DWR_NA0019_01_f_2016_16				
Comment Code					
V2 : Remove the wild growth other than native grasses from the levee slopes.					
Inspector Comment

View of a bush obstructing visibility.

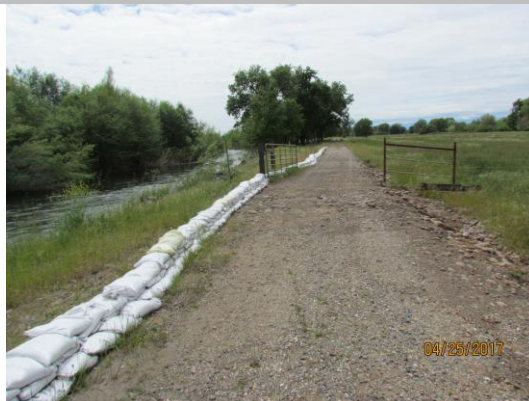
Photo 1 of 1 : SP_2017_NA0019_79_12_20170505_00015.jpg

LM Start	0.81	Rating **	M	Issue No.	12
LM End	0.85	Issue Type +	Ma	Location *	CR
Category	Earthen Levee			GPS Latitude/Longitude	
				Start	End
Item	Erosion / Bank Caving			39.968530 °	39.968248 °
				-122.023305 °	-122.023900 °
DWR ID	DWR_NA0019_02_s _ 2017_12				
Comment Code					
E2 : Schedule repair of erosion site prior to the next inspection.					
Inspector Comment					
Repair the crown roadway.

View of the erosion on the crown roadway.

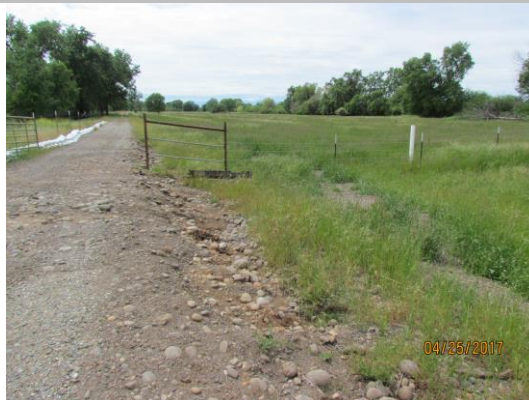
Photo 1 of 1 : SP_2017_NA0019_79_17_20170505_00016.jpg

LM Start	0.81	Rating **	M	Issue No.	17
LM End	0.85	Issue Type +	Ma	Location *	LS
Category	Earthen Levee			GPS Latitude/Longitude	
				Start	End
Item	Erosion / Bank Caving			39.968530 °	39.968248 °
				-122.023305 °	-122.023900 °
DWR ID	DWR_NA0019_02_s _ 2017_17				
Comment Code					
Inspector Comment					
Repair the erosion along the landside slope.

View of the erosion along the landside slope.

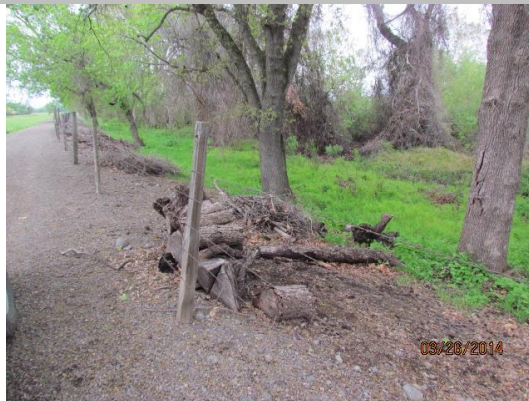
Photo 1 of 1 : SP_2017_NA0019_79_6_20170315_00004.jpg

LM Start	1.28	Rating **	M	Issue No.	6
LM End	1.28	Issue Type +	Ma	Location *	WS
Category	Earthen Levee			GPS Latitude/Longitude	
				Start	End
Item	Encroachments			39.964883 °	39.964883 °
				-122.030655 °	-122.030655 °
DWR ID	DWR_NA0019_02_s_2012_6				
Comment Code					
FW : Firewood					
Inspector Comment

View of the firewood along the waterside slope.

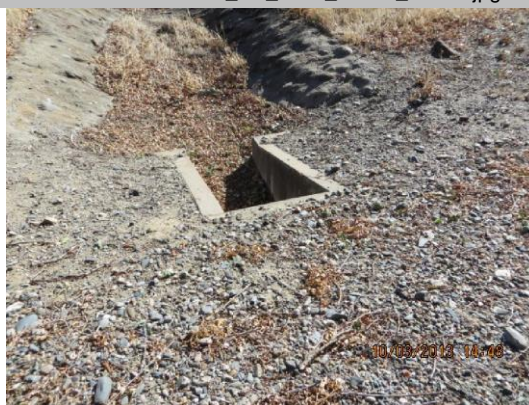
Photo 2 of 3 : UCIP_SP_2017_21793_37068.jpg

Concrete U-shaped headwall on WS toe.

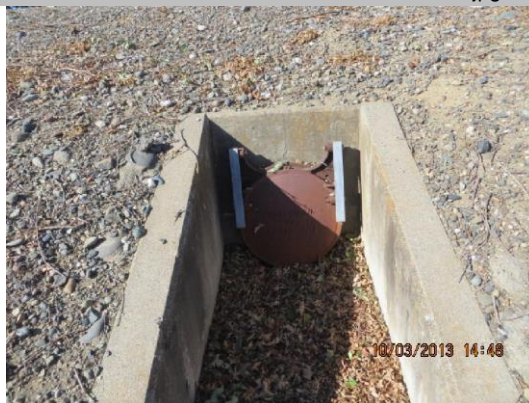
Photo 3 of 3 : UCIP_SP_2017_21793_37067.jpg

LM Start	0.51	Rating **	A/W	Issue No.	919 (cont)	
LM End	0.51	Issue Type +	Ma	Location *	LS	
Category	Supplemental			GPS Latitude/Longitude		
				Start	End	
Item	DWR UCIP LMA Responsibility			40.051211 °	40.051211 °	
				-122.179663 °	-122.179663 °	
DWR ID						
Comment Code						
Inspector Comment						
FS_ID:21793						
DS_ID:20777						
EP_NO: N/A						
Repair Type: No Action Needed						
Crossing Status: Found						
UCIP Comments:						
FIELD_STRUCT_DESC: 24-inch CM drain pipe through levee, 5-feet below crown. Flap gate and concrete "U" headwall on waterward end. Concrete "U" headwall on landward end. Originally included in USACE O+M manual (1963). As-built drawing No. 50-4-3622.						
FS Date: 10/3/2013

Concrete U-shaped headwall and flapgate on WS toe.

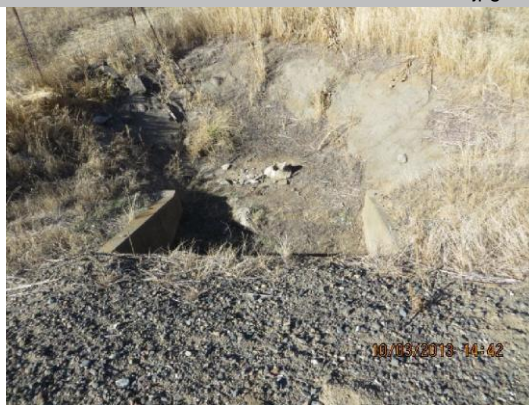
Photo 1 of 3 : UCIP_SP_2017_21792_37065.jpg

LM Start	0.64	Rating **	A/W	Issue No.	920
LM End	0.64	Issue Type +	Ma	Location *	LS
Category	Supplemental			GPS Latitude/Longitude	
				Start	End
Item	DWR UCIP LMA Responsibility			40.051699 °	40.051699 °
				-122.177320 °	-122.177320 °
DWR ID					
Comment Code					
Inspector Comment					
FS_ID:21792 DS_ID:20778 EP_NO: N/A Repair Type: No Action Needed Crossing Status: Found UCIP Comments: FIELD_STRUCT_DESC: 1 of 2: 36-inch CM drain pipe through levee, 8.6 feet below crown. Flap gate and concrete "U" headwall on waterward end. Concrete "U" headwall on landward end. Originally included in USACE O+M manual (1963). As-built drawing No. 50-4-3622. FS Date: 10/3/2013

Concrete U-shaped headwall on LS toe.

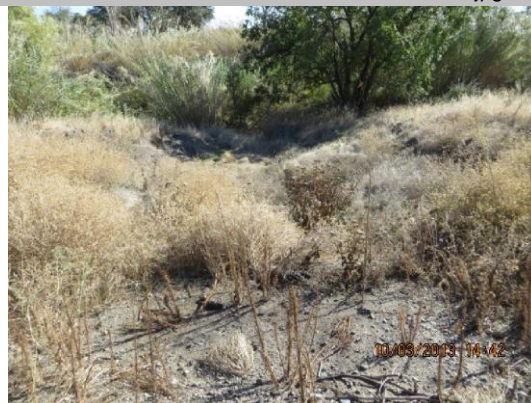
Photo 2 of 3 : UCIP_SP_2017_21792_37064.jpg

LM Start	0.64	Rating **	A/W	Issue No.	920 (cont)
LM End	0.64	Issue Type +	Ma	Location *	LS
Category	Supplemental			GPS Latitude/Longitude	
				Start	End
Item	DWR UCIP LMA Responsibility			40.051699 °	40.051699 °
				-122.177320 °	-122.177320 °
DWR ID					
Comment Code					
Inspector Comment					
FS_ID:21792					
DS_ID:20778					
EP_NO: N/A					
Repair Type: No Action Needed					
Crossing Status: Found					
UCIP Comments:					
FIELD_STRUCT_DESC: 1 of 2: 36-inch CM drain pipe through levee, 8.6 feet below crown. Flap gate and concrete "U" headwall on waterward end. Concrete "U" headwall on landward end. Originally included in USACE O+M manual (1963). As-built drawing No. 50-4-3622.					
FS Date: 10/3/2013

Concrete U-shaped headwall on WS toe.

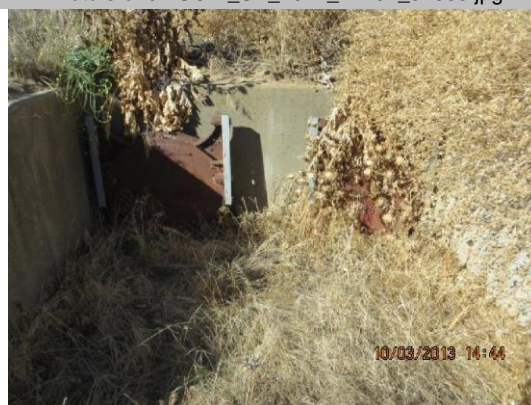
Photo 3 of 3 : UCIP_SP_2017_21792_37063.jpg

Concrete U-shaped headwall and flapgate on WS toe.

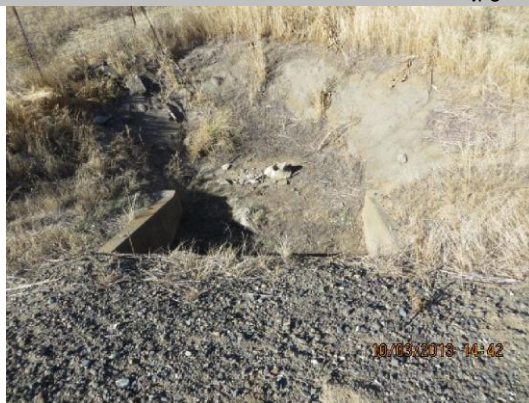
Photo 1 of 3 : UCIP_SP_2017_51443_37061.jpg

FS_ID:51443
DS_ID:20880
EP_NO: N/A
Repair Type: Non-Urgent
Crossing Status: Found
UCIP Comments: 12/05/2016 Crossing has been downgraded from Urgent to Non-Urgent vegetation found on WS but does not appear to prevent proper function of flap gate. Recommend clearing dry vegetation on WS above concrete headwall.(O. Magana - DWR UCIP)10/03/2013 Flapgate operation hindered by soil and vegetation on WS toe. (W. Wylie - DWR UCIP)
FIELD_STRUCT_DESC: 2 of 2: 36-inch corrugated metal drainage pipe through levee, 8.6 feet below crown. Flap gate and concrete "U" headwall located on the waterside (WS) end. Concrete "U" headwall located on the landside (LS) end. [Additional Reference(s): DWR Levee Log, 1992. USACE Sacramento O&M Manual, Unit 510, April 1963, As-built drawing No. 50-4-3622 (HLM 0.65)]
FS Date: 12/5/2016

Concrete U-shaped headwall on LS toe.

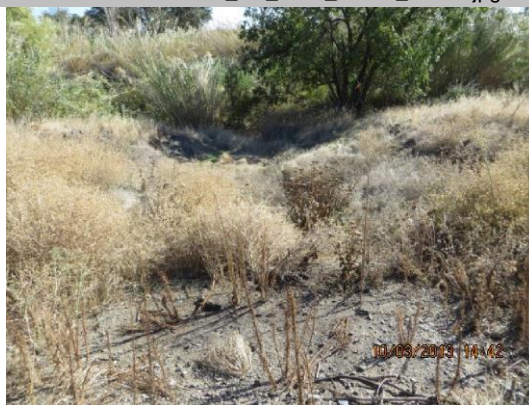
Photo 2 of 3 : UCIP_SP_2017_51443_37060.jpg

Concrete U-shaped headwall on WS toe.

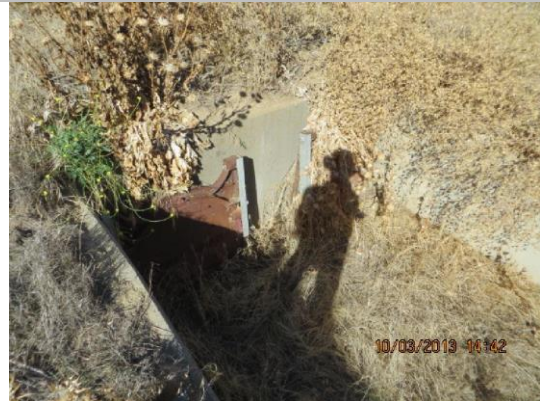
Photo 3 of 3 : UCIP_SP_2017_51443_37059.jpg

Comment Code					
Inspector Comment					
FS_ID:51443 DS_ID:20880 EP_NO: N/A Repair Type: Non-Urgent Crossing Status: Found UCIP Comments: 12/05/2016 Crossing has been downgraded from Urgent to Non-Urgent vegetation found on WS but does not appear to prevent proper function of flap gate. Recommend clearing dry vegetation on WS above concrete headwall.(O. Magana - DWR UCIP)10/03/2013 Flapgate operation hindered by soil and vegetation on WS toe. (W. Wylie - DWR UCIP) FIELD_STRUCT_DESC: 2 of 2: 36-inch corrugated metal drainage pipe through levee, 8.6 feet below crown. Flap gate and concrete "U" headwall located on the waterside (WS) end. Concrete "U" headwall located on the landside (LS) end. [Additional Reference(s): DWR Levee Log, 1992. USACE Sacramento O&M Manual, Unit 510, April 1963, As-built drawing No. 50-4-3622 (HLM 0.65)] FS Date: 12/5/2016

Concrete U-shaped headwall and flapgate on WS toe.

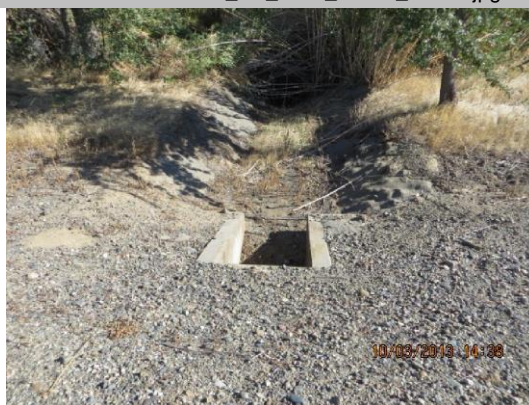
Photo 2 of 3 : UCIP_SP_2017_21790_37056.jpg

Concrete U-shaped headwall on WS toe.

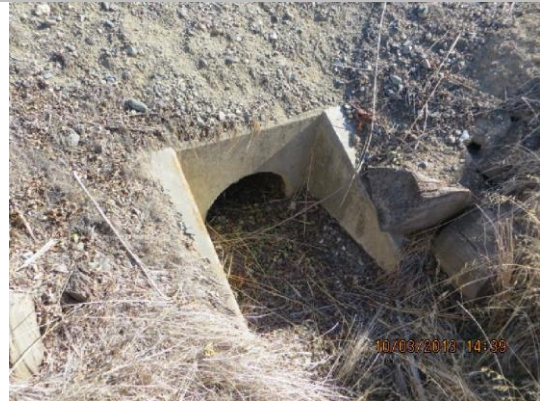
Photo 3 of 3 : UCIP_SP_2017_21790_37055.jpg

LM Start	0.75	Rating **	A/W	Issue No.	922 (cont)
LM End	0.75	Issue Type +	Ma	Location *	LS
Category	Supplemental			GPS Latitude/Longitude	
				Start	End
Item	DWR UCIP LMA Responsibility			40.052194 °	40.052194 °
				-122.175390 °	-122.175390 °
DWR ID					
Comment Code					
Inspector Comment					
FS_ID:21790 DS_ID:20779 EP_NO: N/A Repair Type: No Action Needed Crossing Status: Found UCIP Comments: FIELD_STRUCT_DESC: 24-inch CM drain pipe through levee, 5.8 feet below crown. Flap gate and concrete "U" headwall on waterward end. Concrete "U" headwall on landward end. Originally included in USACE O+M manual (1963). As-built drawing No. 50-4-3622. FS Date: 10/3/2013

Concrete U-shaped headwall on LS toe.

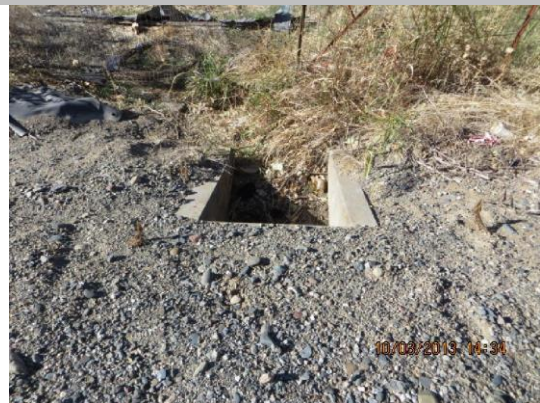
Photo 1 of 3 : UCIP_SP_2017_22827_38970.jpg

LM Start	0.91	Rating **	A/W	Issue No.	923
LM End	0.91	Issue Type +	Ma	Location *	LS
Category	Supplemental			GPS Latitude/Longitude	
				Start	End
Item	DWR UCIP LMA Responsibility			40.053401 °	40.053401 °
				-122.172848 °	-122.172848 °
DWR ID					
Comment Code					
Inspector Comment					
FS_ID:22827					
DS_ID:20780					
EP_NO: N/A					
Repair Type: No Action Needed					
Crossing Status: Found					
UCIP Comments:					
FIELD_STRUCT_DESC: 24-inch CM drain pipe through levee, 4.5-feet below crown. Flap gate and concrete "U" headwall on waterward end. Concrete "U" headwall on landward end. Originally included in USACE O+M manual (1963). As-built drawing No. 50-4-3622.					
FS Date: 10/3/2013

Concrete U-shaped headwall on LS toe.

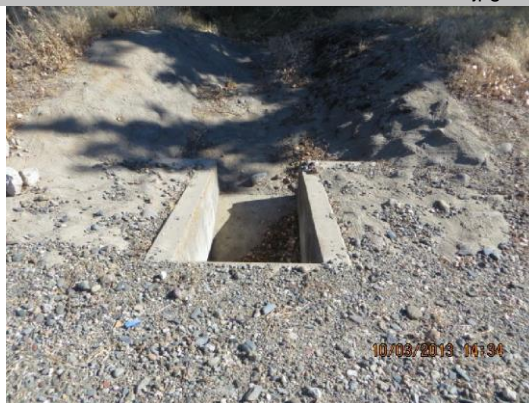
Photo 2 of 3 : UCIP_SP_2017_22827_38969.jpg

LM Start	0.91	Rating **	A/W	Issue No.	923 (cont)	
LM End	0.91	Issue Type +	Ma	Location *	LS	
Category	Supplemental			GPS Latitude/Longitude		
				Start	End	
Item	DWR UCIP LMA Responsibility			40.053401 °	40.053401 °	
				-122.172848 °	-122.172848 °	
DWR ID						
Comment Code						
Inspector Comment						
FS_ID:22827						
DS_ID:20780						
EP_NO: N/A						
Repair Type: No Action Needed						
Crossing Status: Found						
UCIP Comments:						
FIELD_STRUCT_DESC: 24-inch CM drain pipe through levee, 4.5-feet below crown. Flap gate and concrete "U" headwall on waterward end. Concrete "U" headwall on landward end. Originally included in USACE O+M manual (1963). As-built drawing No. 50-4-3622.						
FS Date: 10/3/2013

Concrete U-shaped headwall on WS toe.

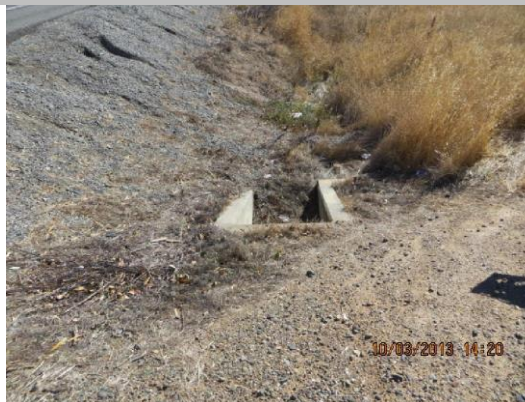
Photo 1 of 3 : UCIP_SP_2017_21788_37050.jpg

LM Start	1.07	Rating **	A/W	Issue No.	924
LM End	1.07	Issue Type +	Ma	Location *	WS
Category	Supplemental			GPS Latitude/Longitude	
				Start	End
Item	DWR UCIP LMA Responsibility			40.052400 °	40.052400 °
				-122.170279 °	-122.170279 °
DWR ID					
Comment Code					
Inspector Comment					
FS_ID:21788					
DS_ID:20790					
EP_NO: N/A					
Repair Type: No Action Needed					
Crossing Status: Found					
UCIP Comments:					
FIELD_STRUCT_DESC: 24-inch CM pipe through levee, 5-feet below crown. Flap gate and concrete "U" headwall on waterward end.					
Concrete "U" headwall on landward end. Originally included in USACE O+M manual (1963). As-built drawing No. 50-4-3622.					
FS Date: 10/3/2013

Concrete U-shaped headwall on WS toe.

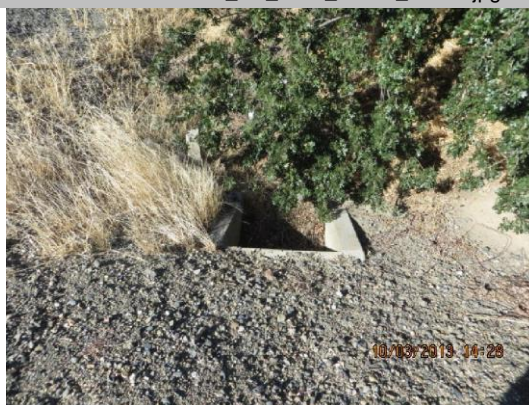
Photo 2 of 2 : UCIP_SP_2017_21786_37047.jpg

Concrete U-shaped headwall on LS toe.

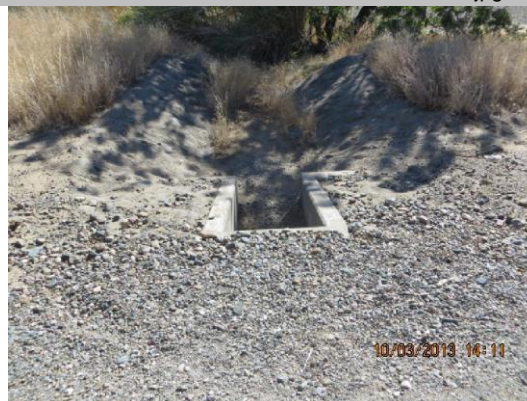
Photo 2 of 3 : UCIP_SP_2017_21778_37036.jpg

LM Start	1.30	Rating **	A/W	Issue No.	926 (cont)	
LM End	1.30	Issue Type +	Ma	Location *	CR	
Category	Supplemental			GPS Latitude/Longitude		
				Start	End	
Item	DWR UCIP LMA Responsibility			40.051563 °	40.051563 °	
				-122.166630 °	-122.166630 °	
DWR ID						
Comment Code						
Inspector Comment						
FS_ID:21778						
DS_ID:20782						
EP_NO: N/A						
Repair Type: No Action Needed						
Crossing Status: Found						
UCIP Comments:						
FIELD_STRUCT_DESC: 24-inch CM pipe through levee, 4.5-feet below crown. Flap gate and concrete "U" headwall on waterward end. Concrete "U" headwall on landward end. Originally included in USACE O+M manual (1963). As-built drawing No. 50-4-3622.						
FS Date: 10/3/2013

Concrete U-shaped headwall on WS toe.

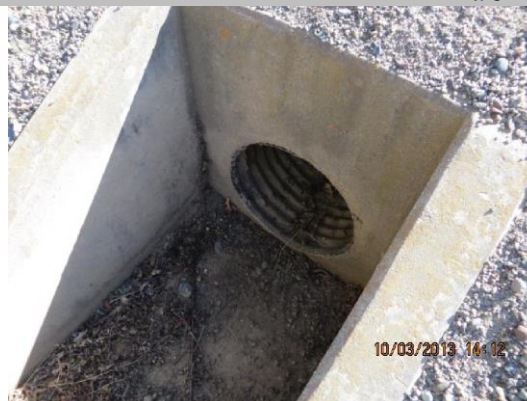
Photo 3 of 3 : UCIP_SP_2017_21778_37035.jpg

Concrete U-shaped headwall on LS toe.

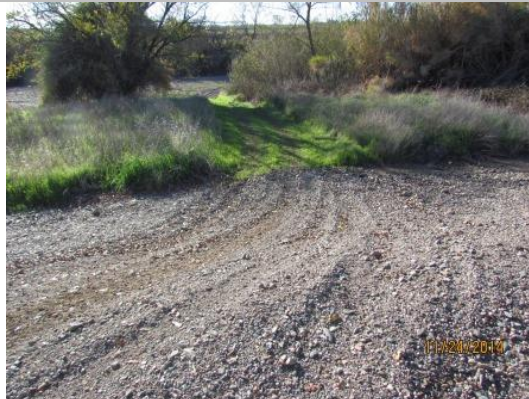
Photo 1 of 1 : SP_2017_NA0019_81_16_20170315_00011.jpg

LM Start	1.39	Rating **	M	Issue No.	16
LM End	1.39	Issue Type +	Ma	Location *	WS
Category	Earthen Levee			GPS Latitude/Longitude	
				Start	End
Item	Slope Stability			40.051493 °	40.051493 °
				-122.164935 °	-122.164935 °
DWR ID	DWR_NA0019_04_f_2014_16				
Comment Code					
S3 : Repair the levee slope damaged by vehicle traffic and prevent access where possible.					
Inspector Comment

View of the slope instability caused by vehicles along the waterside slope.

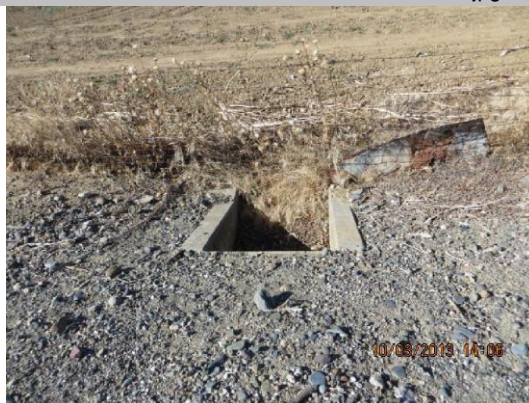
Photo 1 of 3 : UCIP_SP_2017_21776_37029.jpg

LM Start	1.56	Rating **	A/W	Issue No.	927
LM End	1.56	Issue Type +	Ma	Location *	WS
Category	Supplemental			GPS Latitude/Longitude	
				Start	End
Item	DWR UCIP LMA Responsibility			40.052495 °	40.052495 °
				-122.161921 °	-122.161921 °
DWR ID					
Comment Code					
Inspector Comment					
FS_ID:21776					
DS_ID:20783					
EP_NO: N/A					
Repair Type: No Action Needed					
Crossing Status: Found					
UCIP Comments:					
FIELD_STRUCT_DESC: 24-inch CM pipe through levee, 5.8 feet below crown. Flap gate and concrete "U" headwall on waterward end.					
Concrete "U" headwall on landward end. Originally included in USACE O+M manual (1963). As-built drawing No. 50-4-3622.					
FS Date: 10/3/2013

Concrete U-shaped headwall on LS toe.

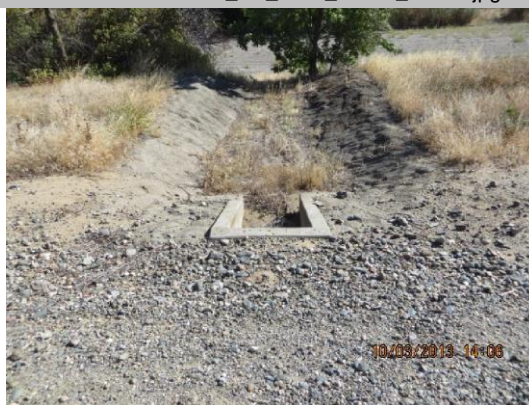
Photo 2 of 3 : UCIP_SP_2017_21776_37028.jpg

Concrete U-shaped headwall on WS toe.

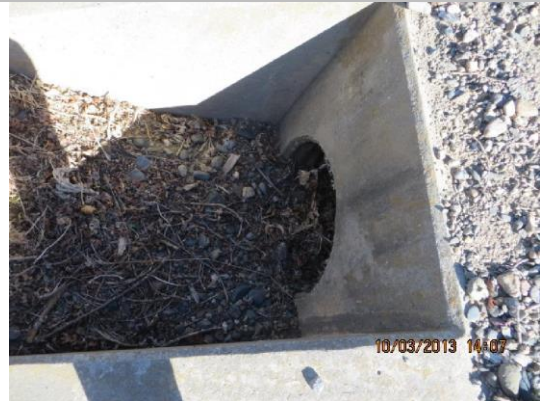
Photo 3 of 3 : UCIP_SP_2017_21776_37027.jpg

Concrete U-shaped headwall on LS toe.

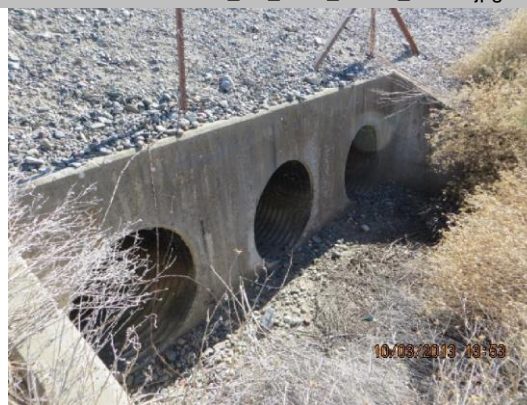
Photo 3 of 3 : UCIP_SP_2017_21769_37002.jpg

Concrete inlet on LS toe.

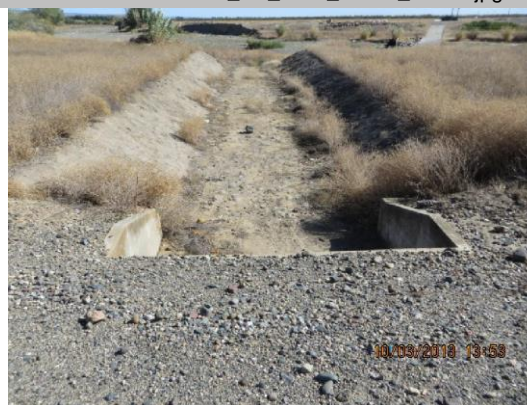
Photo 2 of 3 : UCIP_SP_2017_21768_36999.jpg

Concrete headwall on WS toe.

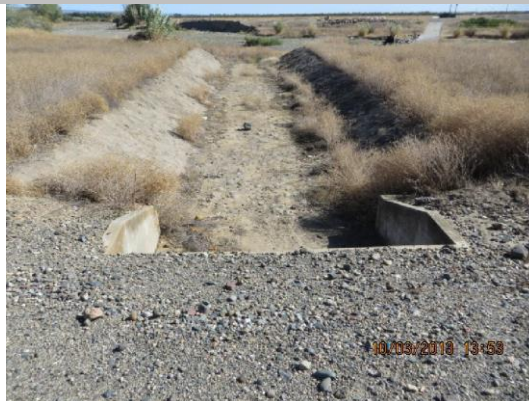
Photo 2 of 3 : UCIP_SP_2017_21767_36995.jpg

Concrete headwall on WS toe.

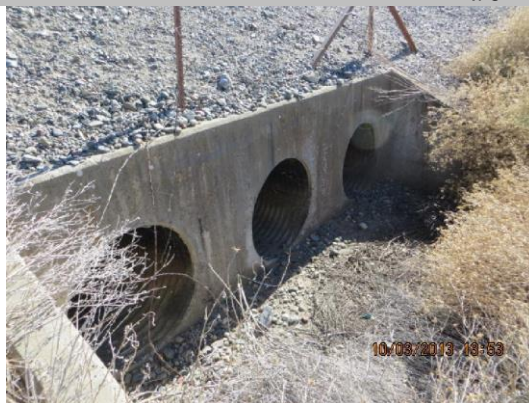
Photo 3 of 3 : UCIP_SP_2017_21767_36994.jpg

Concrete headwall on LS toe.

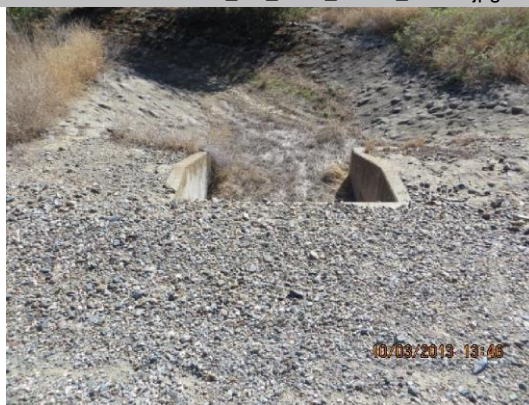
Photo 2 of 3 : UCIP_SP_2017_21766_36991.jpg

Concrete headwall on WS toe.

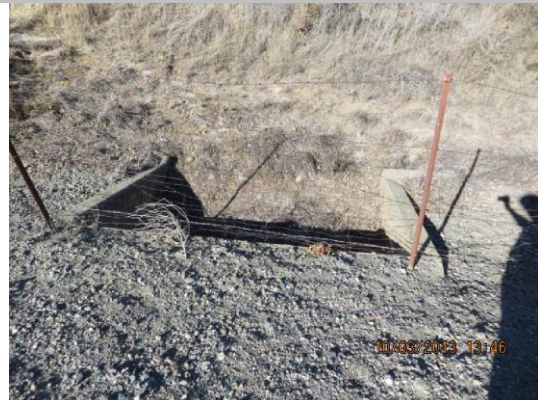
Photo 1 of 3 : UCIP_SP_2017_22828_38978.jpg

Concrete headwall on LS toe.

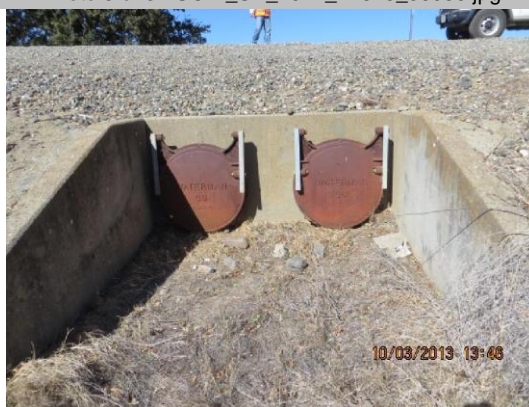
Photo 3 of 3 : UCIP_SP_2017_22828_38980.jpg

Flapgate on headwall at WS toe.

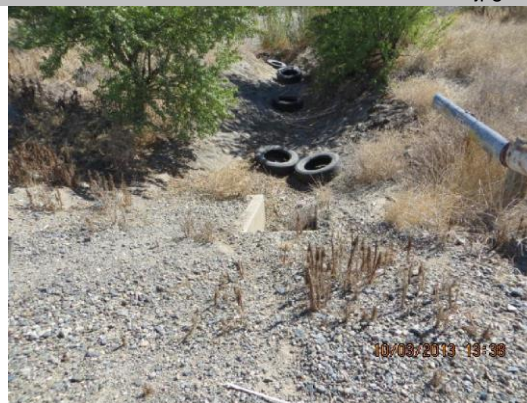
Photo 1 of 3 : UCIP_SP_2017_21763_36982.jpg

Concrete U-shaped headwall on WS slope.

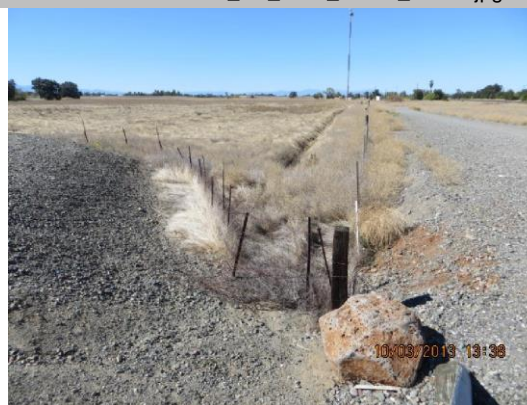
Photo 2 of 3 : UCIP_SP_2017_21763_36981.jpg

Inlet off LS toe in channel.

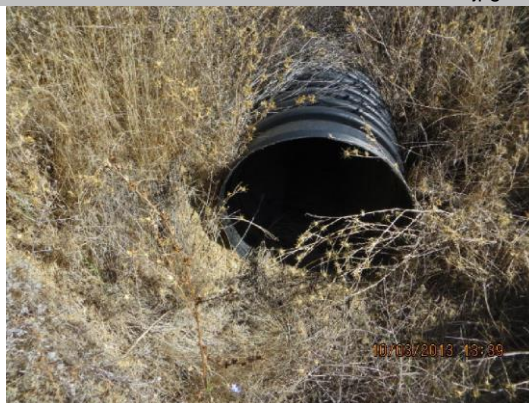
Photo 3 of 3 : UCIP_SP_2017_21763_36980.jpg

HDPE pipe inlet on LS toe.

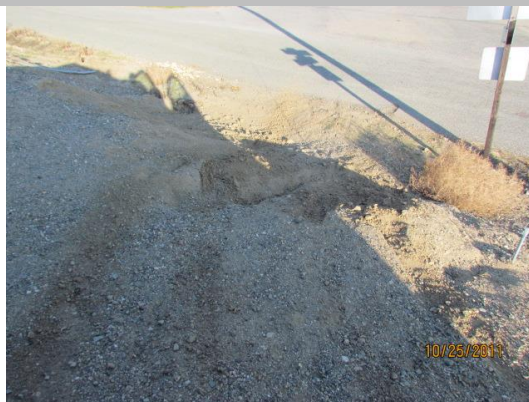
Photo 1 of 1 : SP_2017_NA0019_81_20_20170315_00013.jpg

LM Start	2.43	Rating **	M	Issue No.	20
LM End	2.43	Issue Type +	Ma	Location *	LS
Category	Earthen Levee			GPS Latitude/Longitude	
				Start	End
Item	Slope Stability			40.052417 °	40.052417 °
				-122.146747 °	-122.146747 °
DWR ID	DWR_NA0019_04_s_2012_20				
Comment Code					
S3 : Repair the levee slope damaged by vehicle traffic and prevent access where possible.					
Inspector Comment

View of the slope instability caused by vehicles along the landside slope.

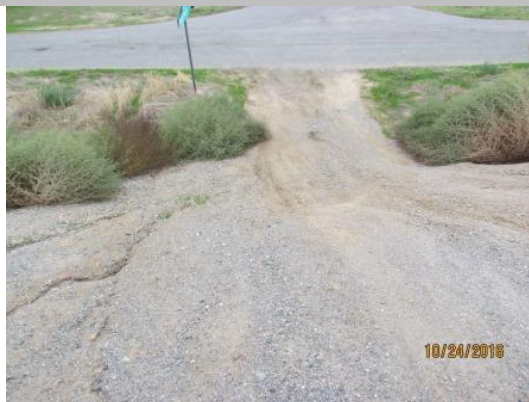
Photo 1 of 1 : SP_2017_NA0019_81_2_20170315_00002.jpg

LM Start	2.51	Rating **	M	Issue No.	2
LM End	2.51	Issue Type +	Ma	Location *	LS
Category	Earthen Levee			GPS Latitude/Longitude	
				Start	End
Item	Slope Stability			40.052872 °	40.052872 °
				-122.145495 °	-122.145495 °
DWR ID	DWR_NA0019_04_s_2012_2				
Comment Code					
S3 : Repair the levee slope damaged by vehicle traffic and prevent access where possible.					
Inspector Comment

View of the slope instability caused by vehicles along the landside slope.

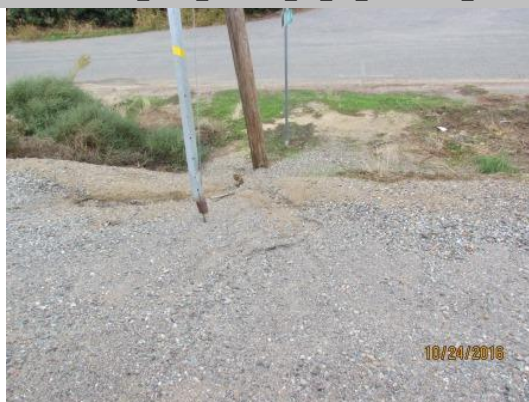
Photo 1 of 1 : SP_2017_NA0019_81_32_20170315_00021.jpg

LM Start	2.58	Rating **	M	Issue No.	32
LM End	2.58	Issue Type +	Ma	Location *	LS
Category	Earthen Levee			GPS Latitude/Longitude	
				Start	End
Item	Slope Stability			40.053767 °	40.053767 °
				-122.144719 °	-122.144719 °
DWR ID	DWR_NA0019_04_f_2016_32				
Comment Code					
S2 : Repair the levee slope damaged by foot traffic and prevent access where possible.					
Inspector Comment

View of the slope instability caused by vehicles along the landside slope.

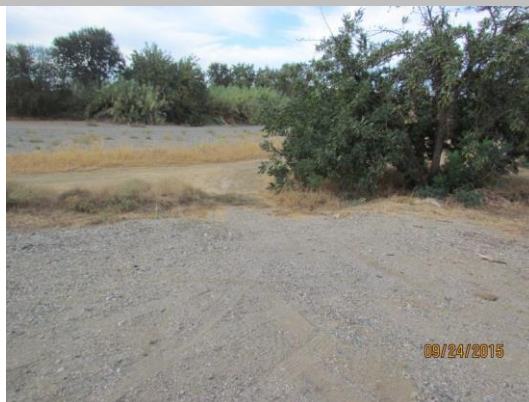
Photo 1 of 1 : SP_2017_NA0019_81_10_20170315_00006.jpg

LM Start	3.01	Rating **	M	Issue No.	10
LM End	3.01	Issue Type +	Ma	Location *	WS
Category	Earthen Levee			GPS Latitude/Longitude	
				Start	End
Item	Slope Stability			40.056388 °	40.056388 °
				-122.139168 °	-122.139168 °
DWR ID	DWR_NA0019_04_s_2012_10				
Comment Code					
S3 : Repair the levee slope damaged by vehicle traffic and prevent access where possible.					
Inspector Comment

View of the slope instability caused by vehicles along the landside slope.

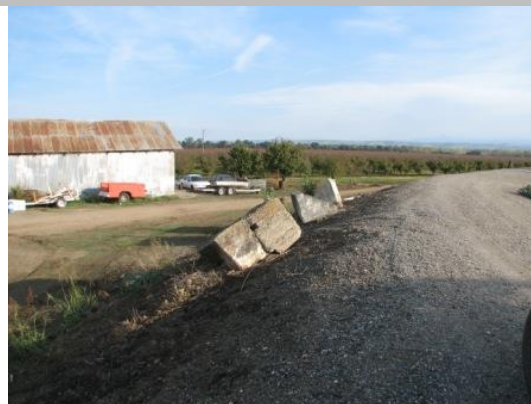
Photo 1 of 1 : SP_2017_NA0019_81_1_20170315_00001.jpg

LM Start	3.11	Rating **	M	Issue No.	1
LM End	3.13	Issue Type +	Ma	Location *	LS
Category	Earthen Levee			GPS Latitude/Longitude	
				Start	End
Item	Encroachments			40.057083 °	40.057291 °
				-122.137935 °	-122.137743 °
DWR ID	DWR_NA0019_04_s_2012_1				
Comment Code					
ST : Stairway					
Inspector Comment					
Remove concnere blocks, concrete pipes, and concrete stairs from the landside slope.

View of the concrete stairways on the slope.

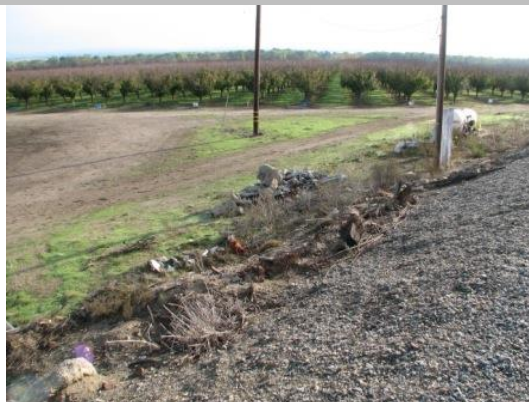
Photo 1 of 1 : SP_2017_NA0019_81_6_20170315_00005.jpg

LM Start	3.31	Rating **	M	Issue No.	6	
LM End	3.31	Issue Type +	Ma	Location *	LS	
Category	Earthen Levee			GPS Latitude/Longitude		
				Start		End
Item	Encroachments			40.057558 °		40.057558 °
				-122.134417 °		-122.134417 °
DWR ID	DWR_NA0019_04_s_2012_6					
Comment Code						
GA : Garbage						
Inspector Comment

View of the garbage and metal along the landside slope and toe of the levee.

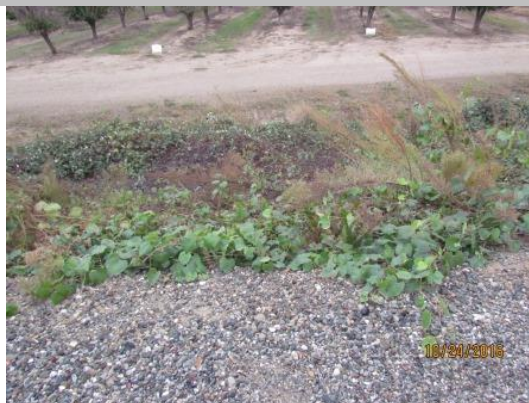
Photo 1 of 1 : SP_2017_NA0019_81_39_20170315_00023.jpg

LM Start	3.40	Rating **	M	Issue No.	39
LM End	3.44	Issue Type +	Ma	Location *	LS
Category	Earthen Levee			GPS Latitude/Longitude	
				Start	End
Item	Vegetation			40.056546 °	40.055906 °
				-122.133530 °	-122.133294 °
DWR ID	DWR_NA0019_04_f_2016_39				
Comment Code					
V2 : Remove the wild growth other than native grasses from the levee slopes.					
Inspector Comment

View of the blackberries along the landside slope blocking visibility and access.

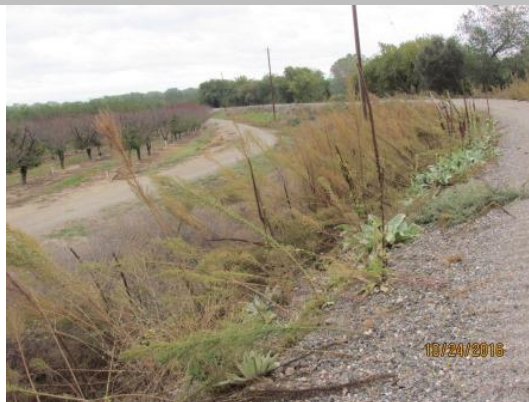
Photo 1 of 1 : SP_2017_NA0019_81_40_20170315_00024.jpg

LM Start	3.49	Rating **	M	Issue No.	40
LM End	3.55	Issue Type +	Ma	Location *	LS
Category	Earthen Levee			GPS Latitude/Longitude	
				Start	End
Item	Vegetation			40.055505 °	40.055388 °
				-122.132694 °	-122.131489 °
DWR ID	DWR_NA0019_04_f_2016_40				
Comment Code					
V1 : Control annual grass and weeds on the levee slopes and easements.					
Inspector Comment

View of the annual grass along the landside slope.

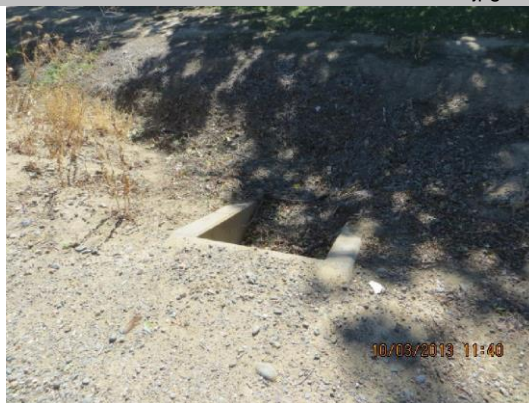
Photo 1 of 3 : UCIP_SP_2017_21744_36945.jpg

LM Start	0.11	Rating **	A/W	Issue No.	20
LM End	0.11	Issue Type +	Ma	Location *	LS
Category	Supplemental			GPS Latitude/Longitude	
				Start	End
Item	DWR UCIP LMA Responsibility			40.051702 °	40.051702 °
				-122.189922 °	-122.189922 °
DWR ID					
Comment Code					
Inspector Comment					
FS_ID:21744					
DS_ID:20799					
EP_NO: N/A					
Repair Type: No Action Needed					
Crossing Status: Found					
UCIP Comments:					
FIELD_STRUCT_DESC: 24-inch CM drainpipe through the levee, 5.4					
feet below the crown. Flap gate on waterward end. Concrete "U"					
headwalls on the waterward and landward ends. Originally included in					
USACE O+M Manual (1963). As-built drawing 50-4-3622					
FS Date: 10/3/2013

Concrete headwall on LS toe.

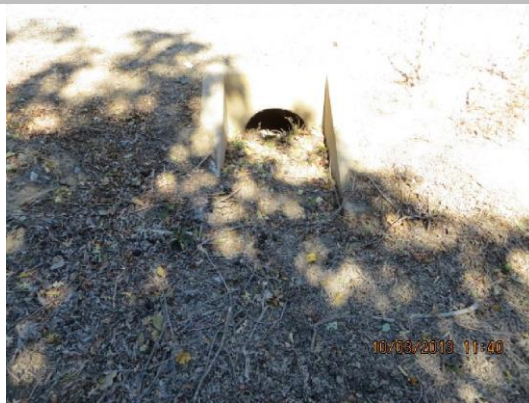
Photo 2 of 3 : UCIP_SP_2017_21744_36944.jpg

Concrete headwall on LS toe.

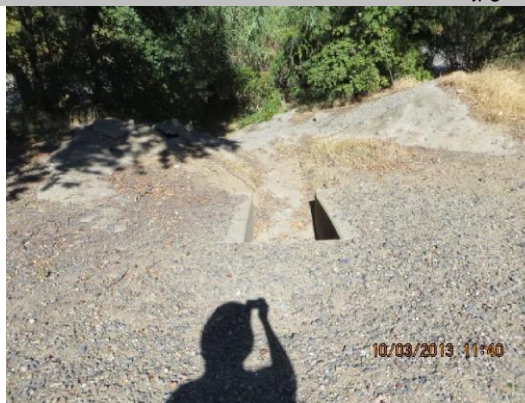
Photo 3 of 3 : UCIP_SP_2017_21744_36943.jpg

LM Start	0.11	Rating **	A/W	Issue No.	20 (cont)	
LM End	0.11	Issue Type +	Ma	Location *	LS	
Category	Supplemental			GPS Latitude/Longitude		
				Start	End	
Item	DWR UCIP LMA Responsibility			40.051702 °	40.051702 °	
				-122.189922 °	-122.189922 °	
DWR ID						
Comment Code						
Inspector Comment						
FS_ID:21744						
DS_ID:20799						
EP_NO: N/A						
Repair Type: No Action Needed						
Crossing Status: Found						
UCIP Comments:						
FIELD_STRUCT_DESC: 24-inch CM drainpipe through the levee, 5.4						
feet below the crown. Flap gate on waterward end. Concrete "U"						
headwalls on the waterward and landward ends. Originally included in						
USACE O+M Manual (1963). As-built drawing 50-4-3622						
FS Date: 10/3/2013

Concrete U-shaped headwall on WS slope.

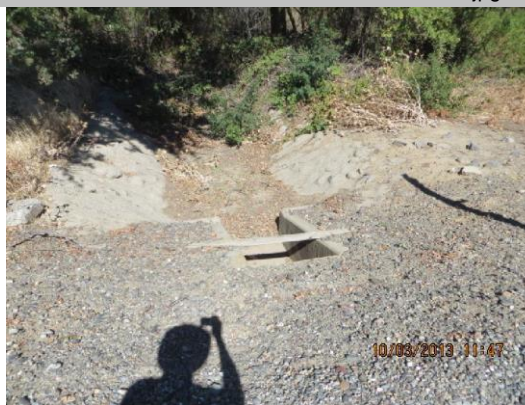
Photo 1 of 3 : UCIP_SP_2017_41124_36953.jpg

LM Start	0.50	Rating **	M	Issue No.	21
LM End	0.50	Issue Type +	Ma	Location *	LS
Category	Supplemental			GPS Latitude/Longitude	
				Start	End
Item	DWR UCIP LMA Responsibility			40.050585 °	40.050585 °
				-122.182972 °	-122.182972 °
DWR ID					
Comment Code					
Inspector Comment					
FS_ID:41124					
DS_ID:20801					
EP_NO: N/A					
Repair Type: Non-Urgent					
Crossing Status: Found					
UCIP Comments: Debris inside pipe at WS toe needs to be removed as it may prevent proper operation of the flapgate.					
FIELD_STRUCT_DESC: 24-inch CM pipe through the levee, 5.2 feet below the crown. Flap gate on waterward end. Concrete "U" headwalls on the waterward and landward ends. Originally included in USACE O+M Manual (1963). As-built drawing 50-4-3622					
FS Date: 10/3/2013

Concrete headwall on WS toe.

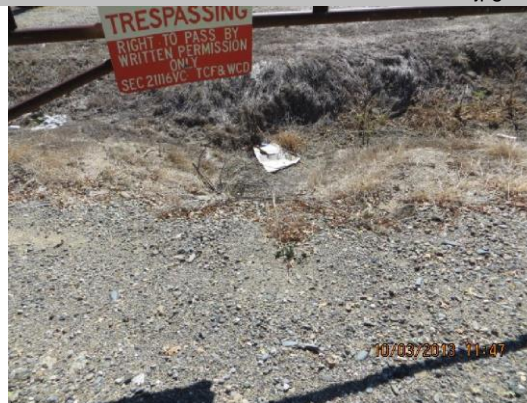
Photo 2 of 3 : UCIP_SP_2017_41124_36952.jpg

LM Start	0.50	Rating **	M	Issue No.	21 (cont)
LM End	0.50	Issue Type +	Ma	Location *	LS
Category	Supplemental			GPS Latitude/Longitude	
				Start	End
Item	DWR UCIP LMA Responsibility			40.050585 °	40.050585 °
				-122.182972 °	-122.182972 °
DWR ID					
Comment Code					
Inspector Comment					
FS_ID:41124					
DS_ID:20801					
EP_NO: N/A					
Repair Type: Non-Urgent					
Crossing Status: Found					
UCIP Comments: Debris inside pipe at WS toe needs to be removed as it may prevent proper operation of the flapgate.					
FIELD_STRUCT_DESC: 24-inch CM pipe through the levee, 5.2 feet below the crown. Flap gate on waterward end. Concrete "U" headwalls on the waterward and landward ends. Originally included in USACE O+M Manual (1963). As-built drawing 50-4-3622					
FS Date: 10/3/2013

Inlet at LS toe.

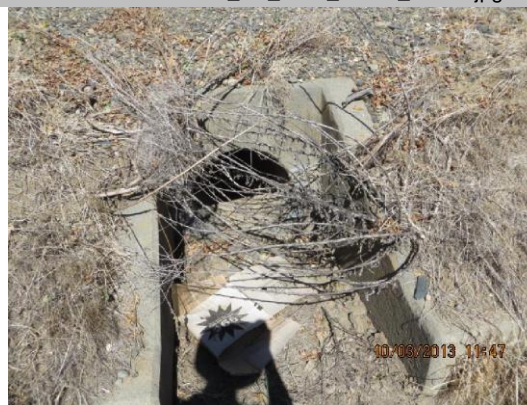
Photo 3 of 3 : UCIP_SP_2017_41124_36951.jpg

Concrete headwall at LS toe.

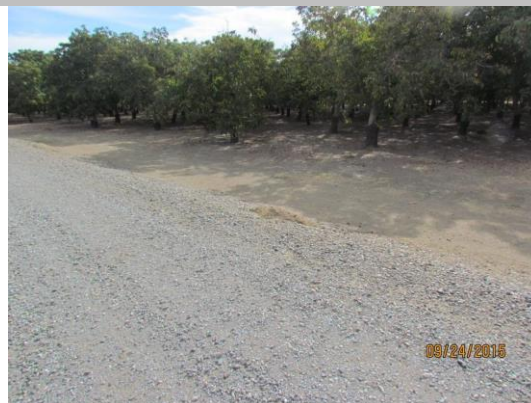
Photo 1 of 1 : SP_2017_NA0019_82_8_20170315_00003.jpg

LM Start	0.94	Rating **	A/W	Issue No.	8
LM End	1.05	Issue Type +	Ma	Location *	LS
Category	Earthen Levee			GPS Latitude/Longitude	
				Start	End
Item	Animal Control			40.051360 °	40.052361 °
				-122.175063 °	-122.173450 °
DWR ID	DWR_NA0019_05_f_2015_8				
Comment Code					
A1 : Exterminate rodents and backfill and compact or grout burrows.					
Inspector Comment					
Grout the rodent the holes. Rodents appeared in holes in center of crown and on LS slope on 4/26/16.

View of the rodent holes along the landside slope.

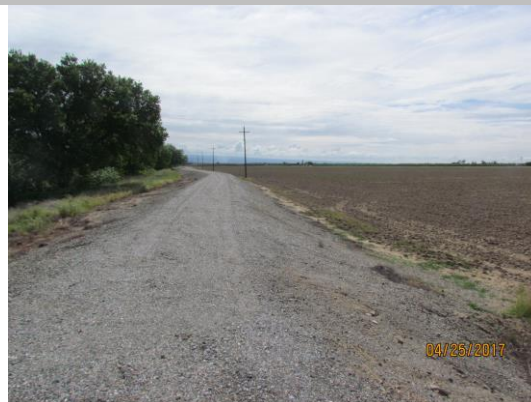
Photo 1 of 1 : SP_2017_NA0019_82_16_20170505_00020.jpg

LM Start	1.28	Rating **	A	Issue No.	16	
LM End	1.28	Issue Type +	Ma	Location *	LS	
Category	Earthen Levee			GPS Latitude/Longitude		
				Start		End
Item	Vegetation			40.051365 °		40.051365 °
				-122.169852 °		-122.169852 °
DWR ID	DWR_NA0019_05_s_2017_16					
Comment Code						
V1 : Control annual grass and weeds on the levee slopes and easements.						
Inspector Comment						
The vegetation was removed from both slopes.

View of no vegetation on both slopes.
